SBNF and SCMF Restoration Sites Before and After

Requirements for OHV Restoration Success

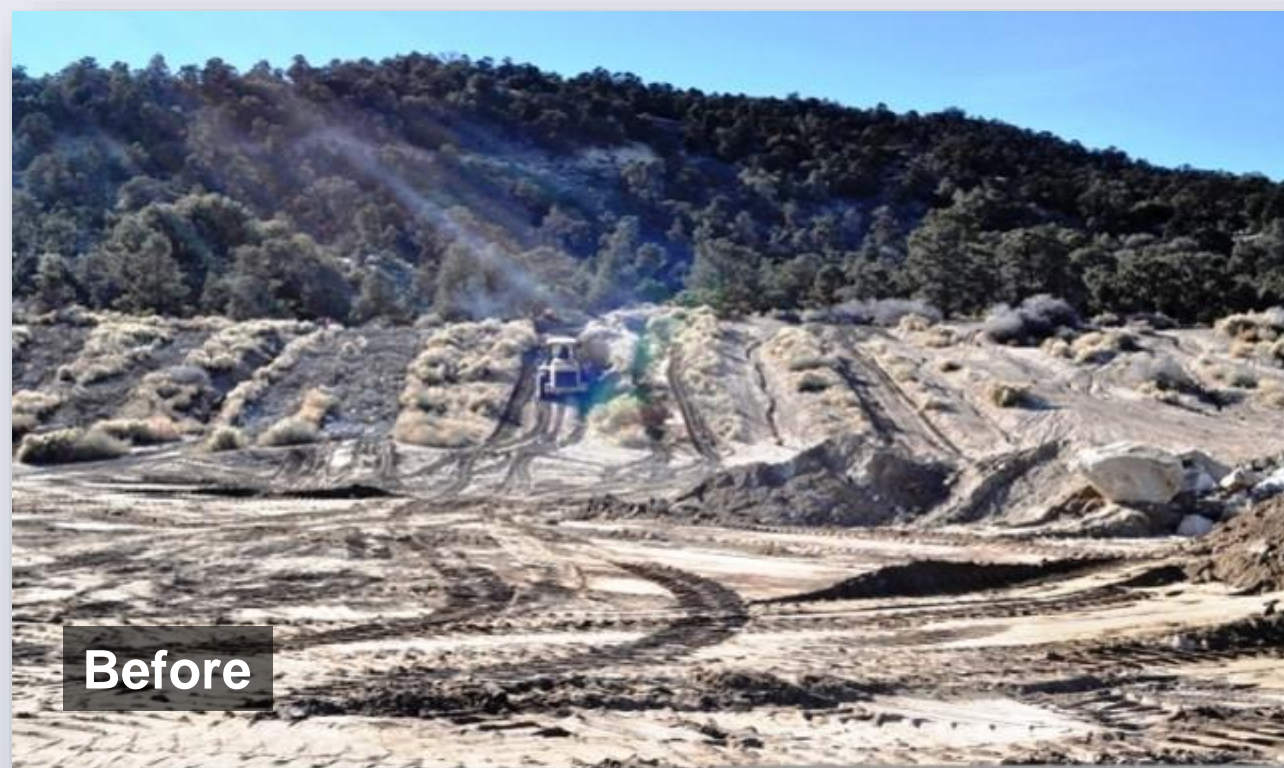
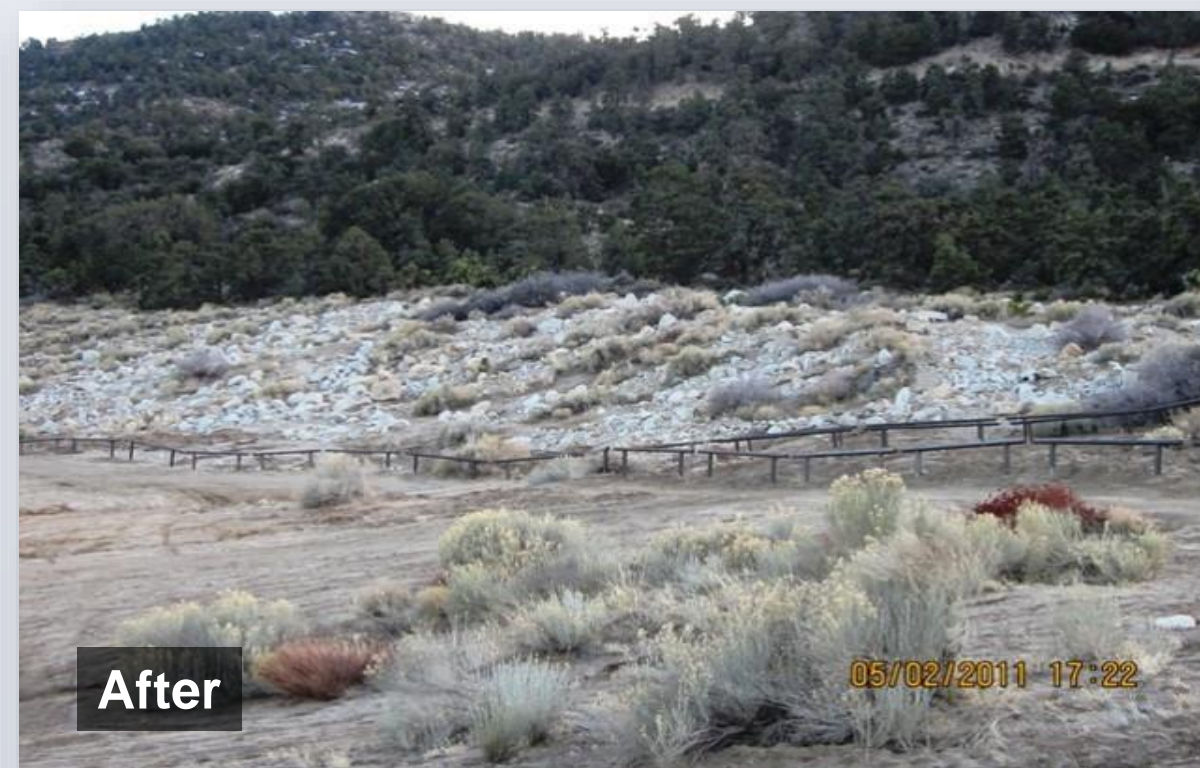
Cactus Flat OHV Staging Area

Soil erosion and sedimentation prompted restoration of slopes using native seed, rock and slashing to stabilize eroded trails. Designating trails, delineating the staging area footprint and planting container plants over 7 years resulted in success.

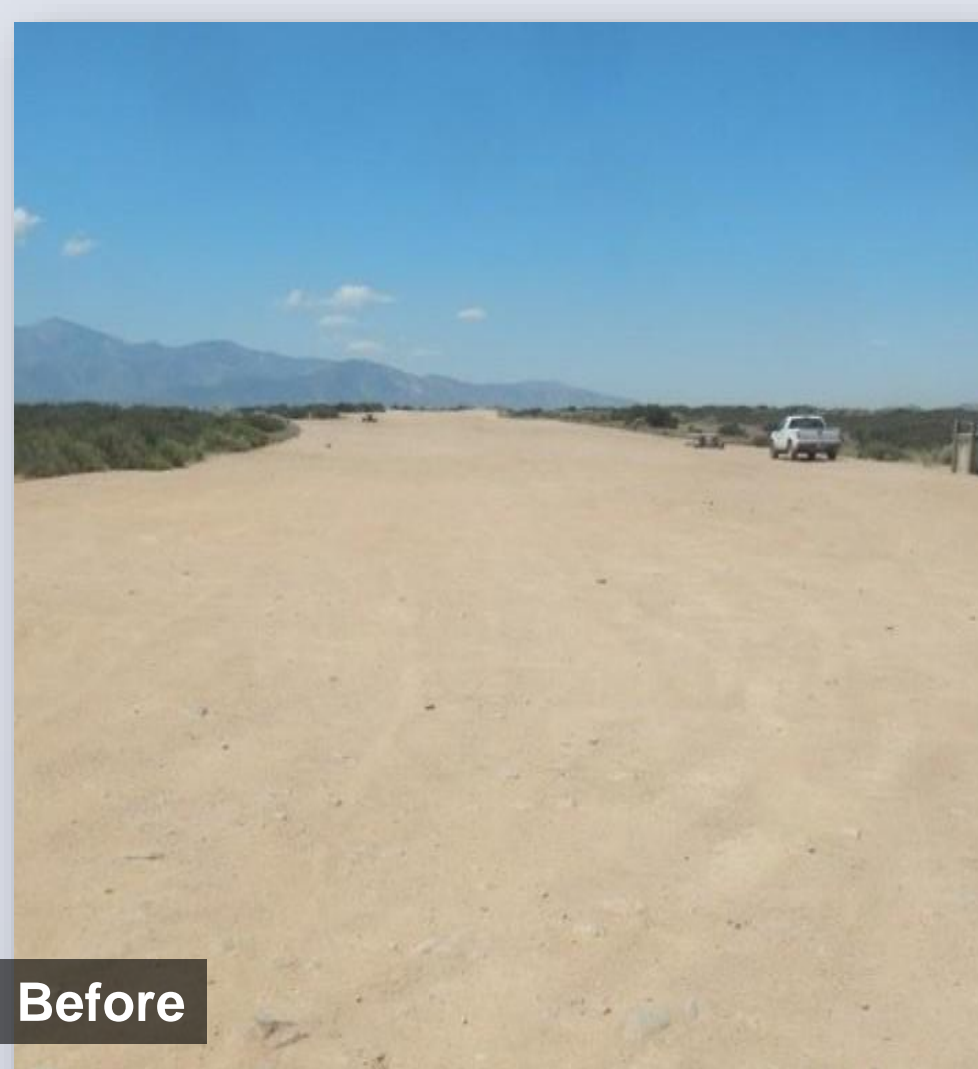
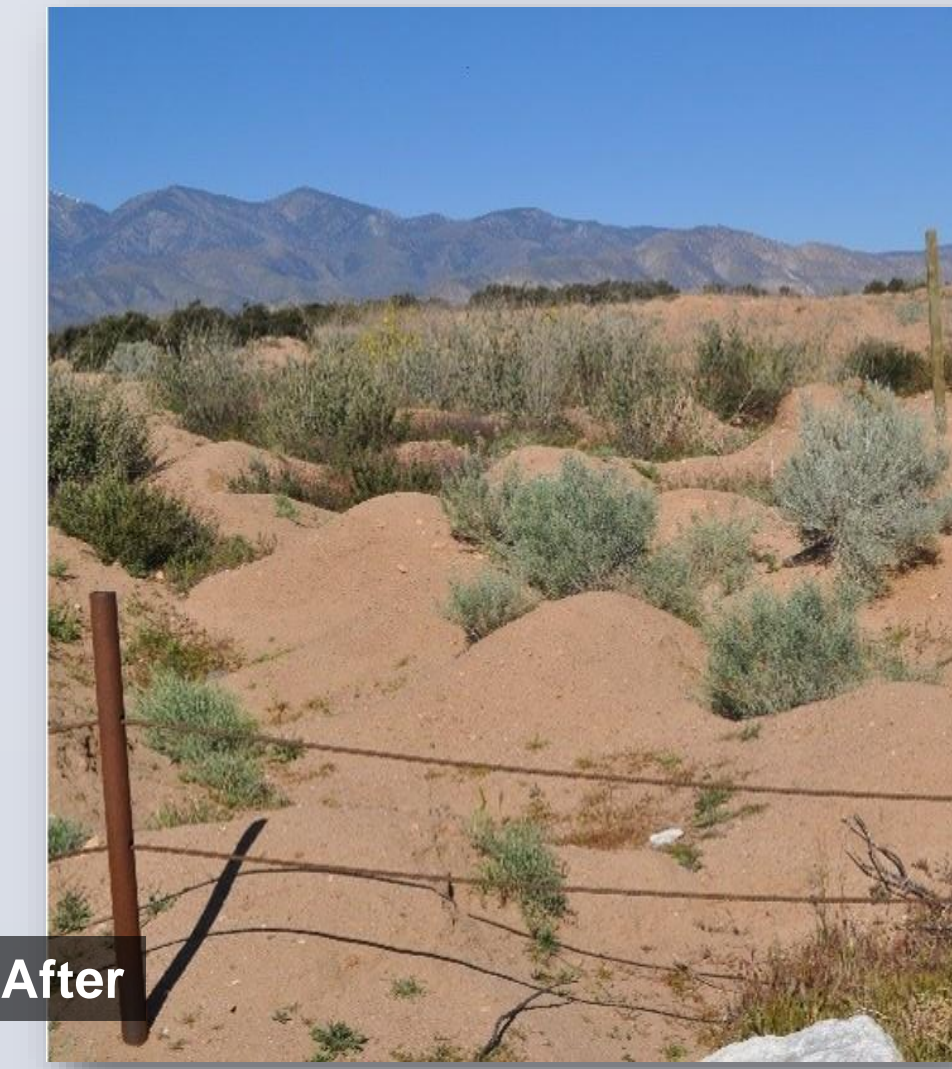
Summit OHV Staging Area

NEPA for Summit Staging Area Designation required restoration of 1 acre that was contributing sediment into arroyo toad habitat. The west parking area was chunked to decompact soils, increase water infiltration, develop planting sites for revegetation and reduce establishment of invasive weeds. The container plants grown in these basins grew more quickly than any of our other treatments.

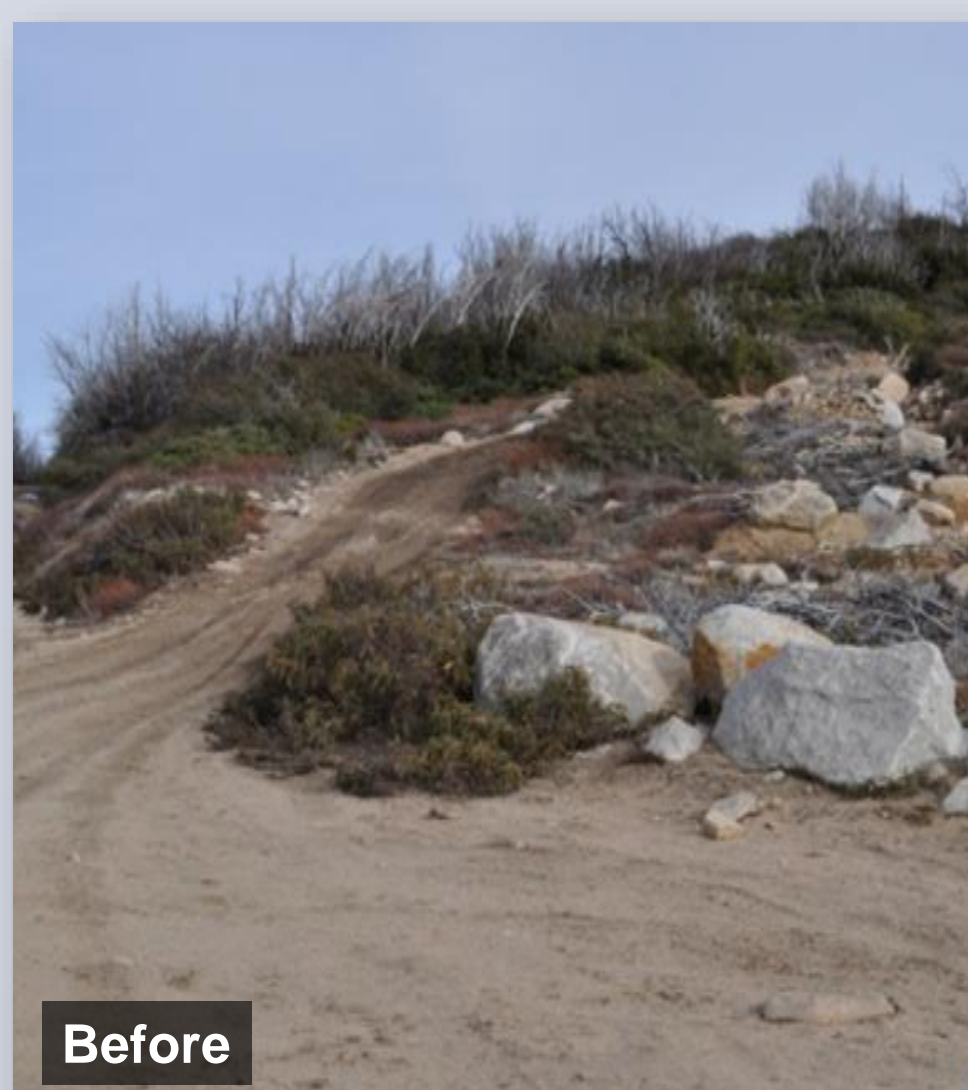
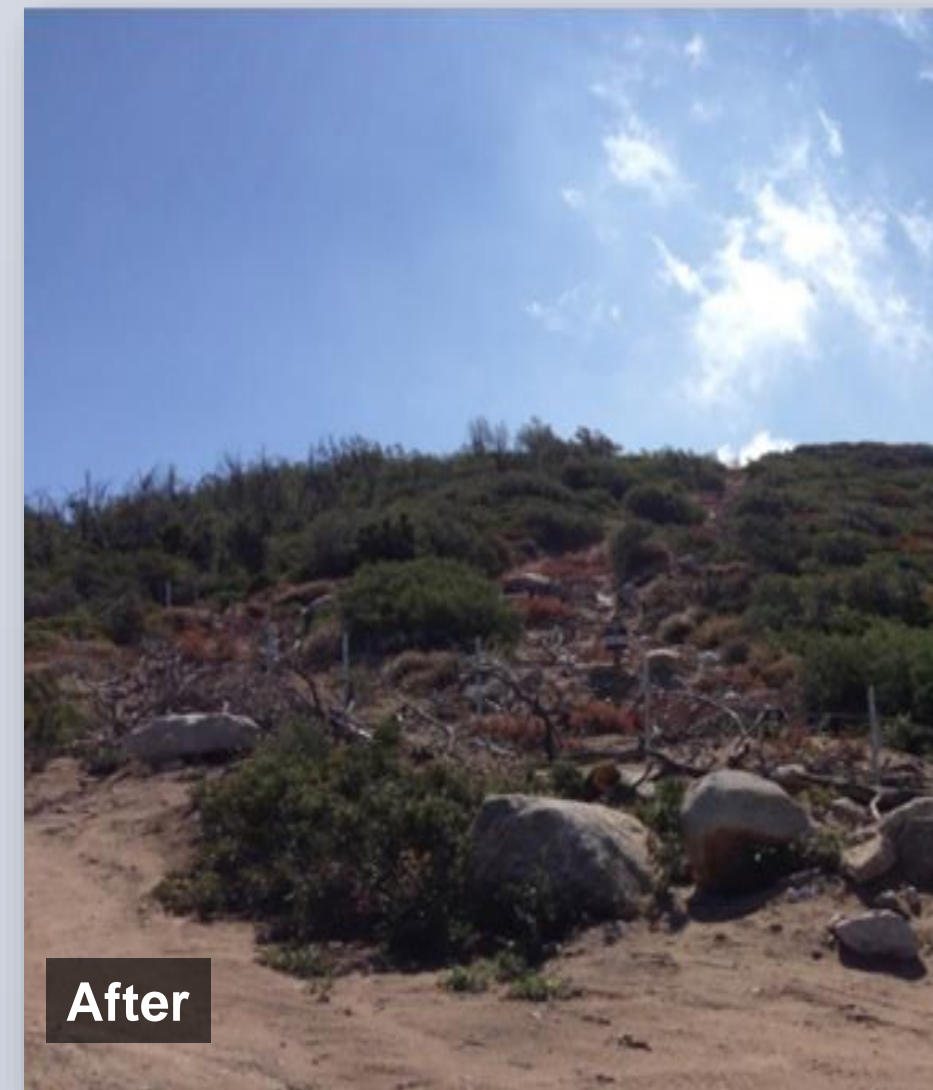
Cleghorn Unauthorized Routes

Chunking badly compacted sites, along with seeding and planting native plants while using boulders and fencing to restrict off route use, resulted in successful restoration.

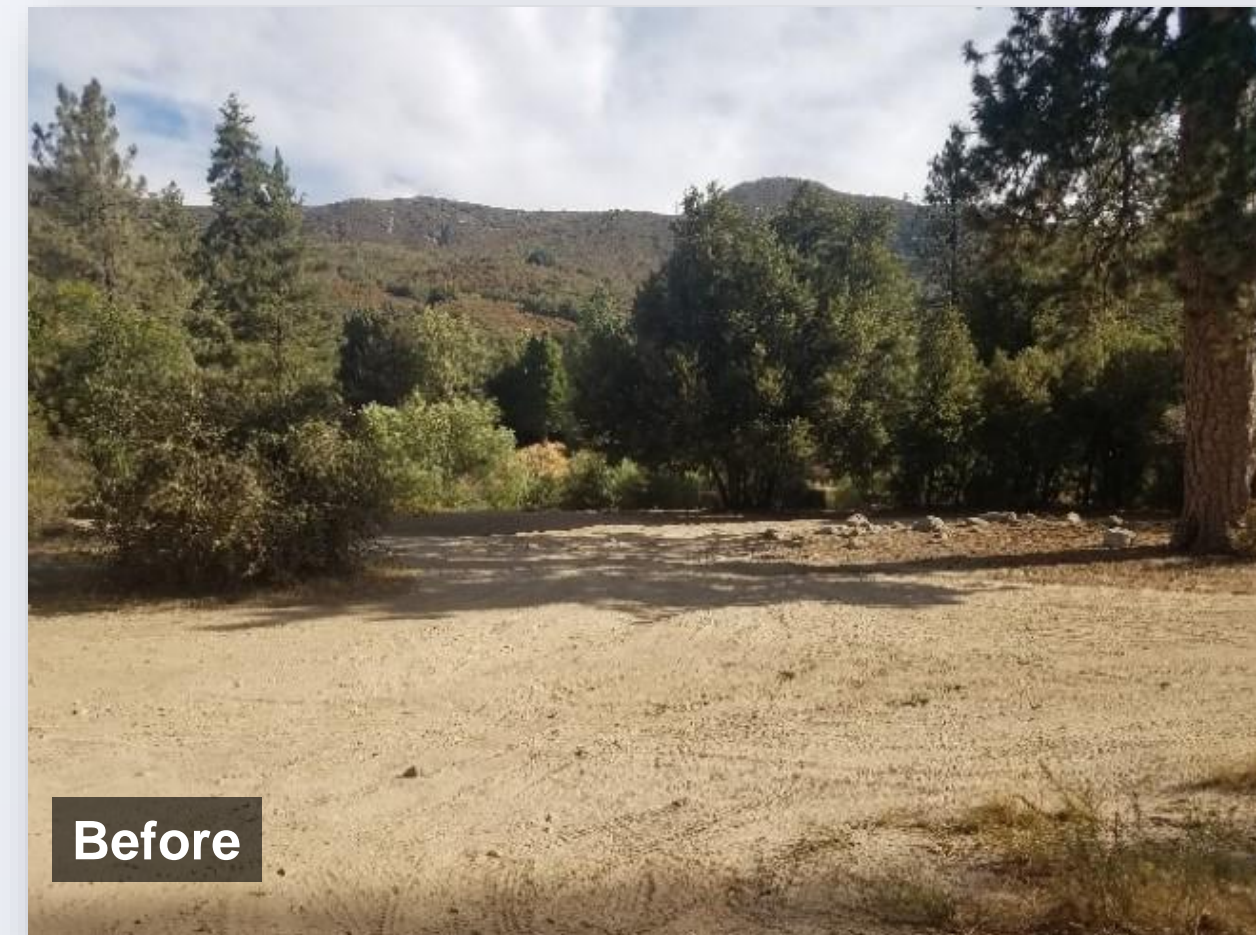
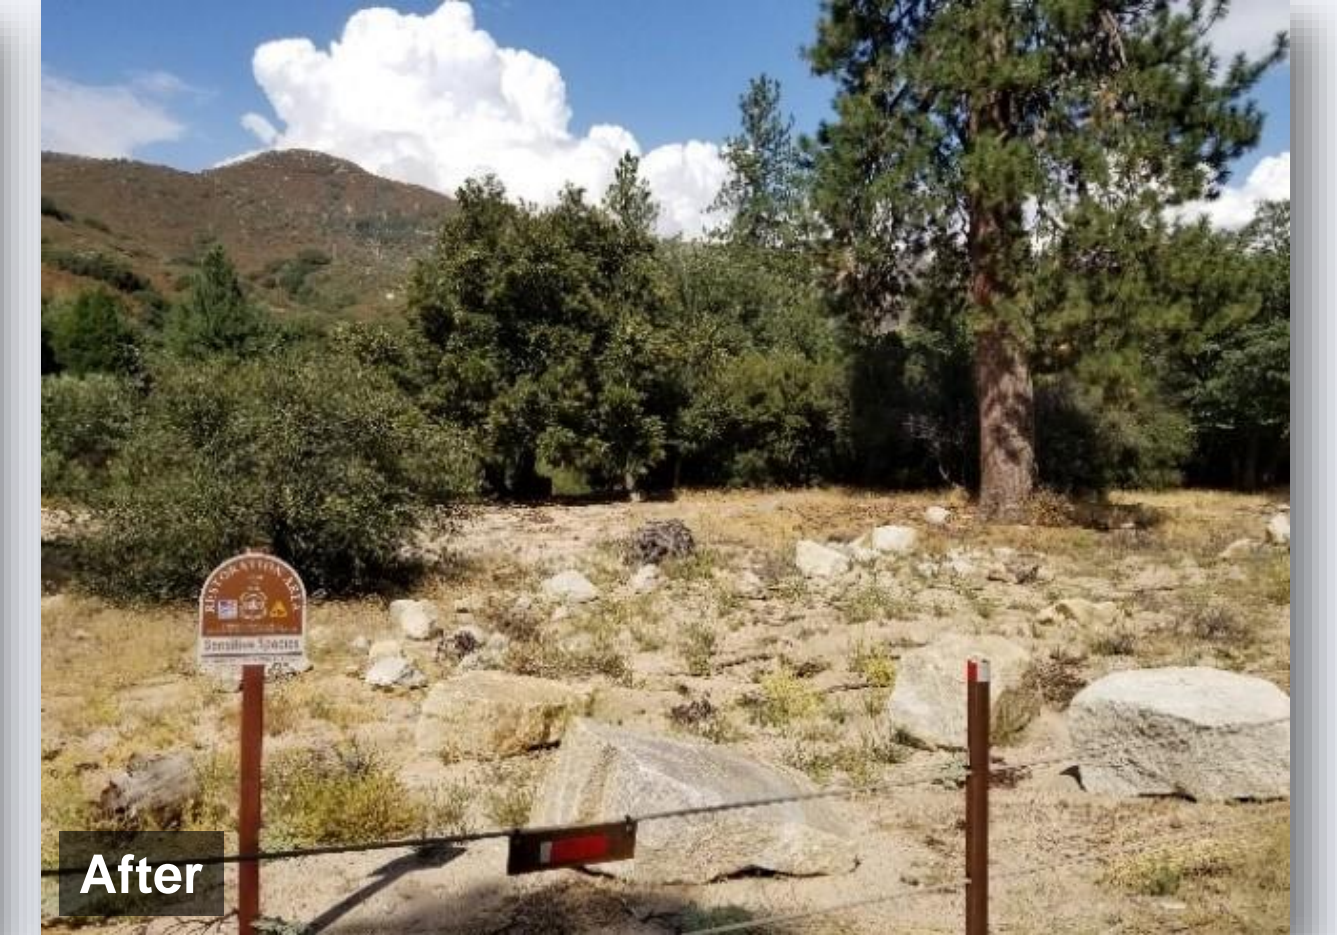
Miller Unofficial Staging Area

Compacted parking/camping site along a fork of the Mojave River was ripped, enhanced with topsoil, heavily seeded, and slashed in 2018. Weeding has been the most important maintenance requirement at this site.

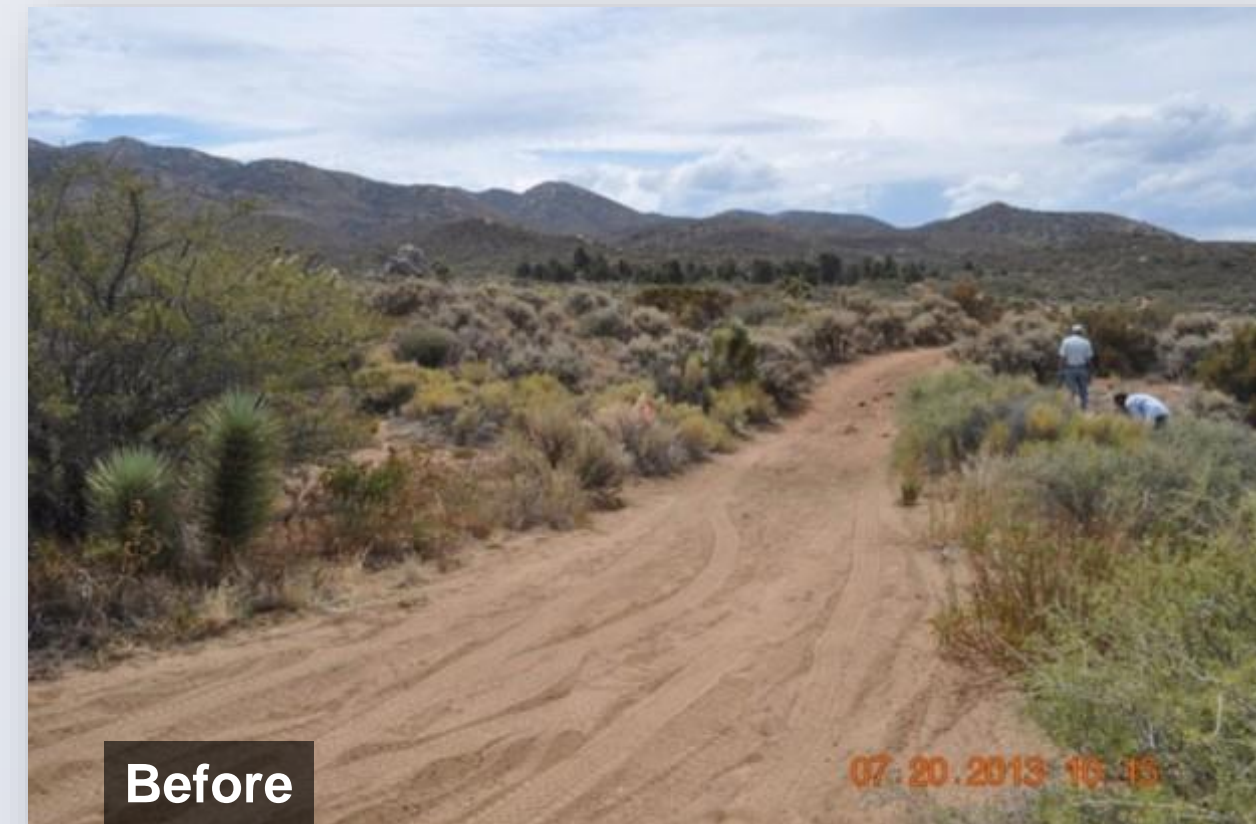
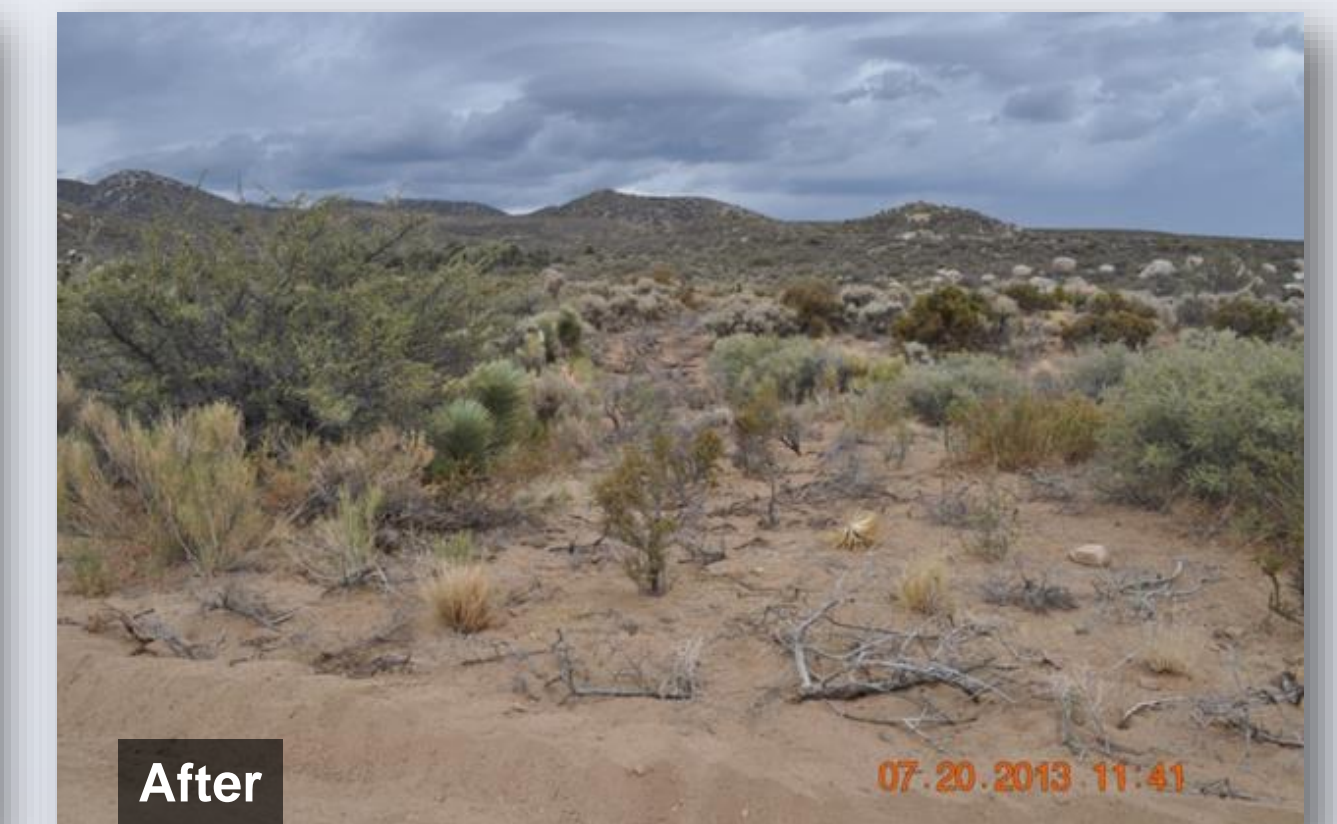
Unauthorized Routes, South Side of 3N17

USFS, SCMF staff and UCC crews heavily slashed and seeded this unauthorized route in 2015. It held, and seeds grew to enhance vegetative cover. Having a UCC crew to complete this intensive method of slashing/seeding was key to success.

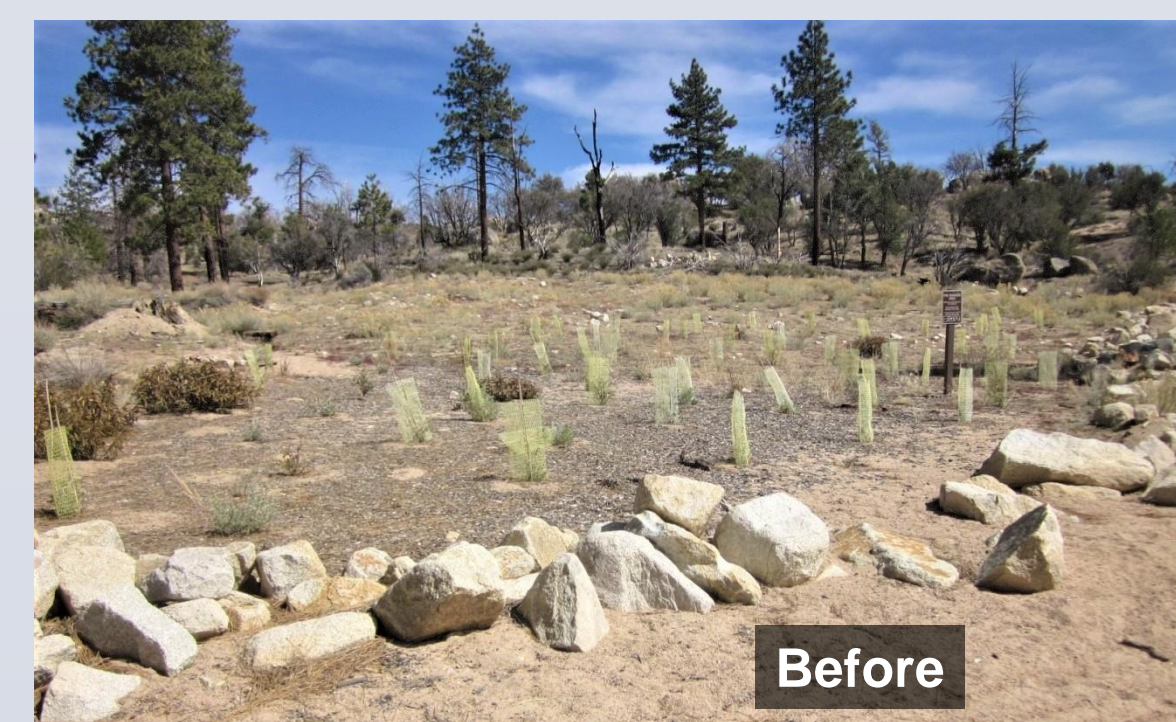
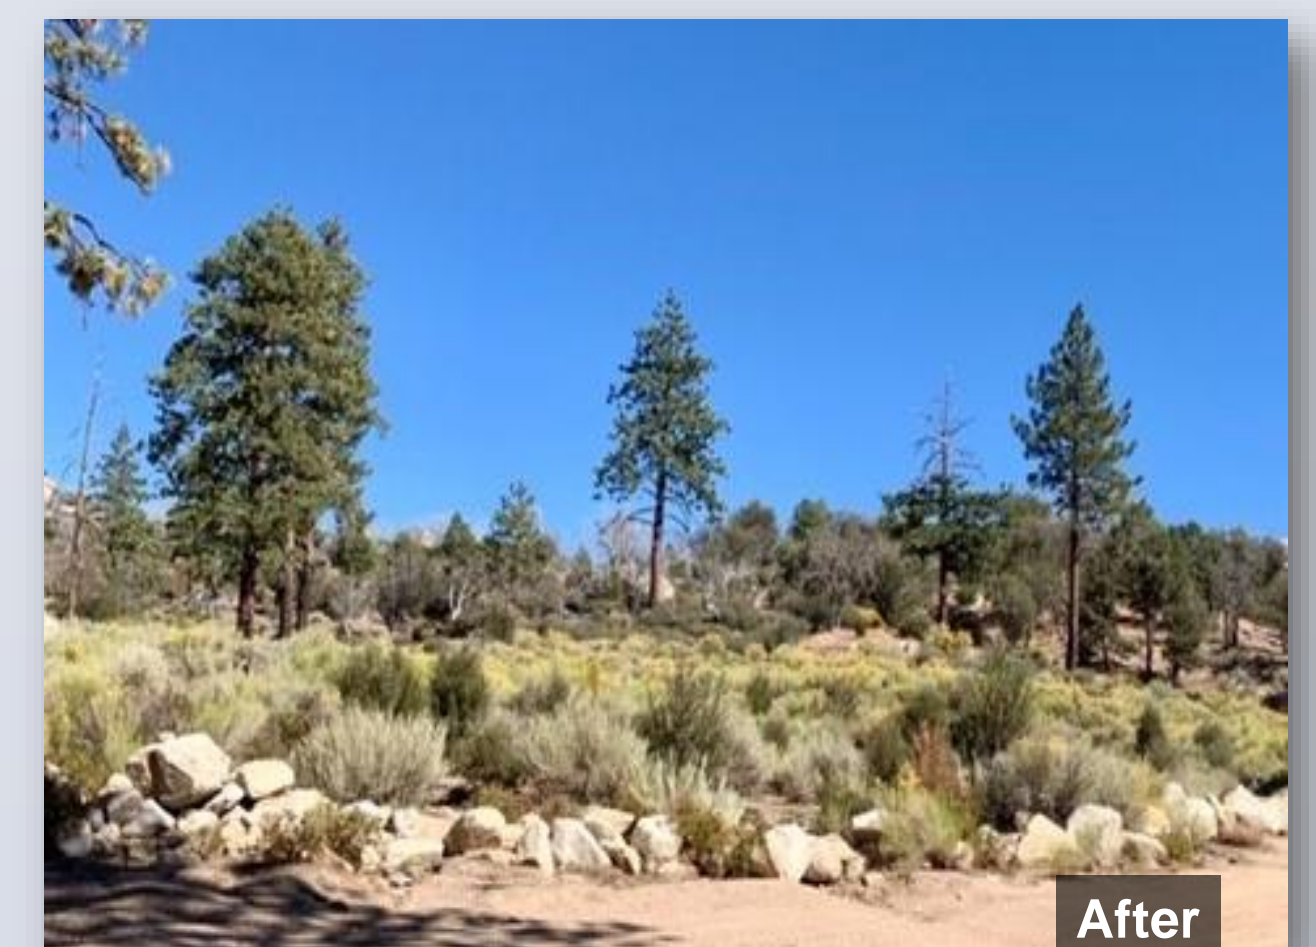
3N16 Cienega Redonda Triangle

This area had potential to become an unauthorized staging area along a popular Green Sticker route. A boulder barricade was installed and container plants were planted into augered holes. Additional plants were added annually until cover was achieved in 2019.

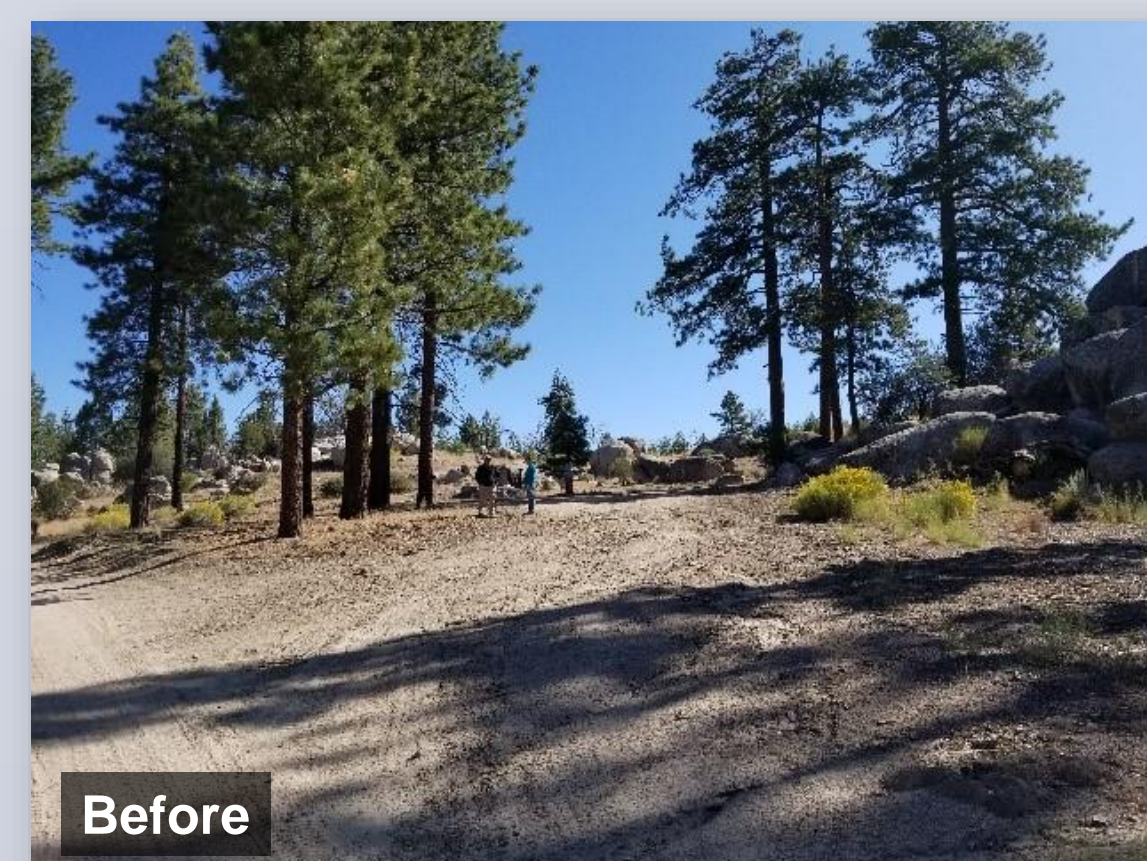
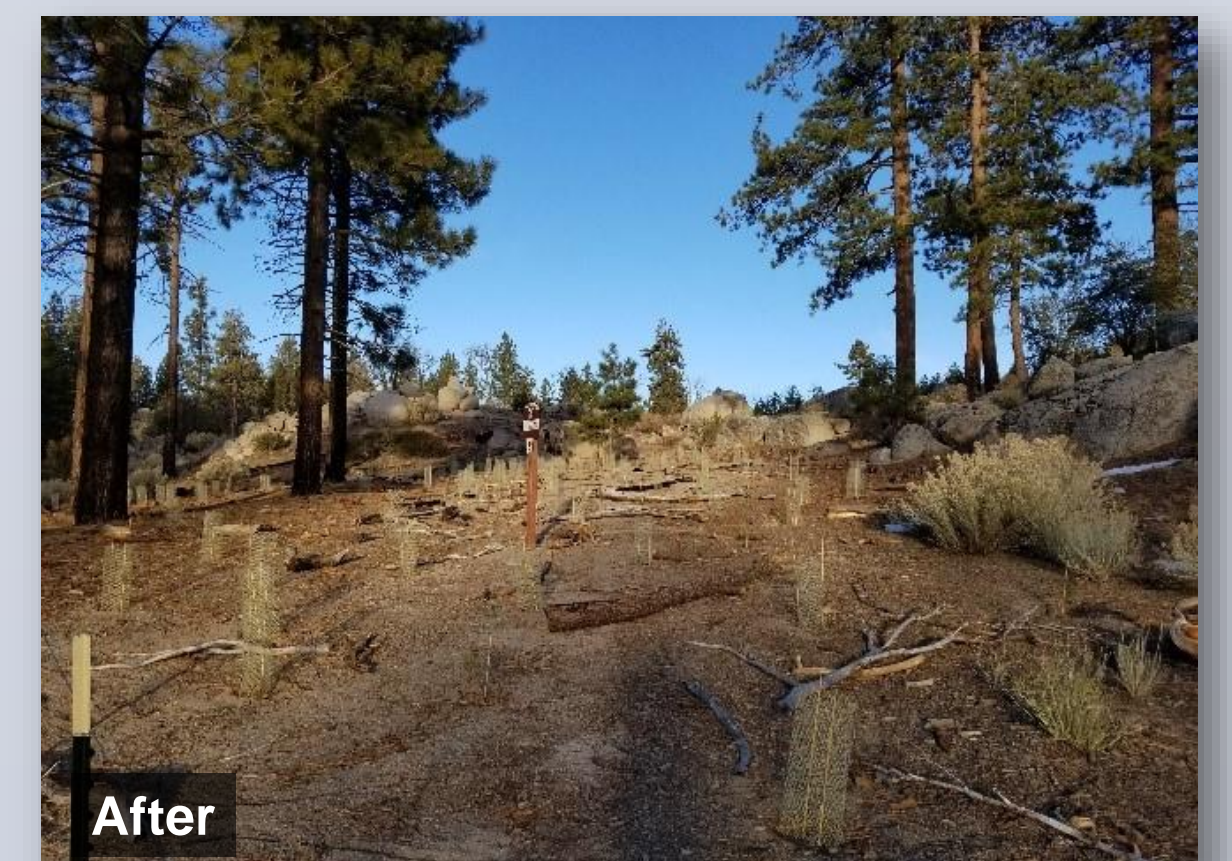
3N16 West of New Rattlesnake Trailing Site Development

One of 5 eroding sites along a popular Green Sticker route that was fenced, signed, planted and seeded to restore land that connects to the new Rattlesnake Trails and Trailing Site Development Project. Restoration can assist in sustainable development. This planting, completed September 2019 is 4 months old.
